DIOCESE OF MONZE

DIOCESAN DEVELOPMENT DEPARTMENT

PROGRESS REPORT

This progress report highlights activities that have since been carried out in Fumbo Parish of Gwembe District where a Lukonde Community borehole was drilled to a depth of 90 meters. The valley area is well known for moving from one extreme to another either by way of experiencing a drought or floods. Inadequate water within village perimeters has been a source of concern for Lukonde Community and this problem will soon be a thing of the past as the process in the provision of safe and clean water is well under way and this is all made possible through the financial support from Fairhandeln. The pumping test revealed that community members will greatly benefit from this water facility having recorded a yield of 1.53 liters per second during the pumping test.

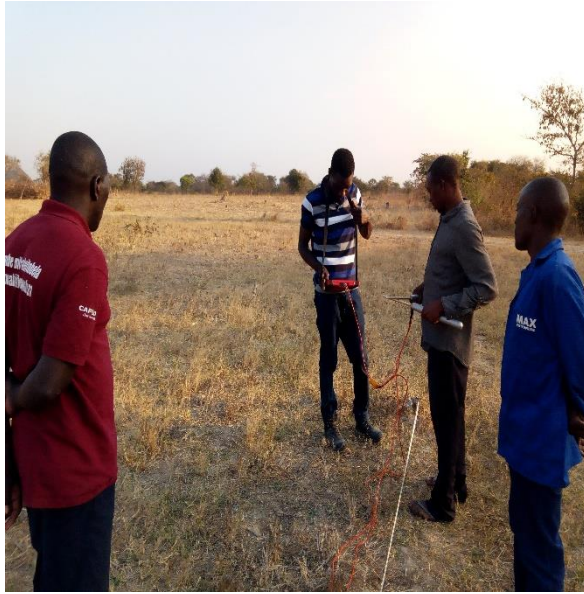
Figure 3 Geophysical Water Sitting

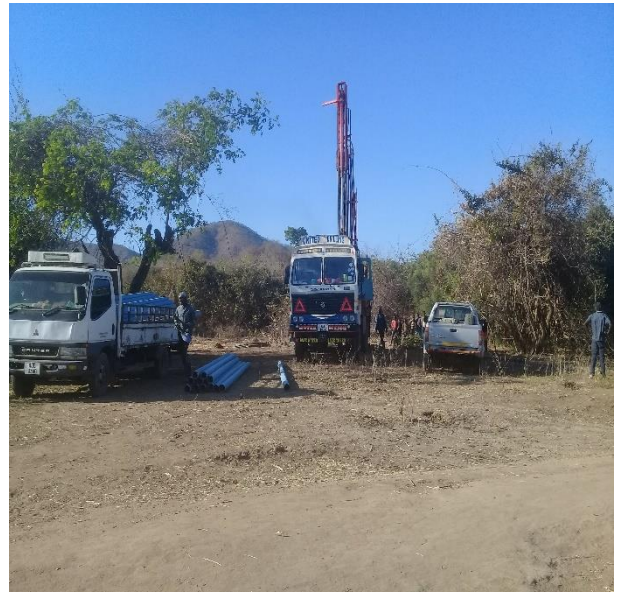
Figure 1 Drilling on the selected site

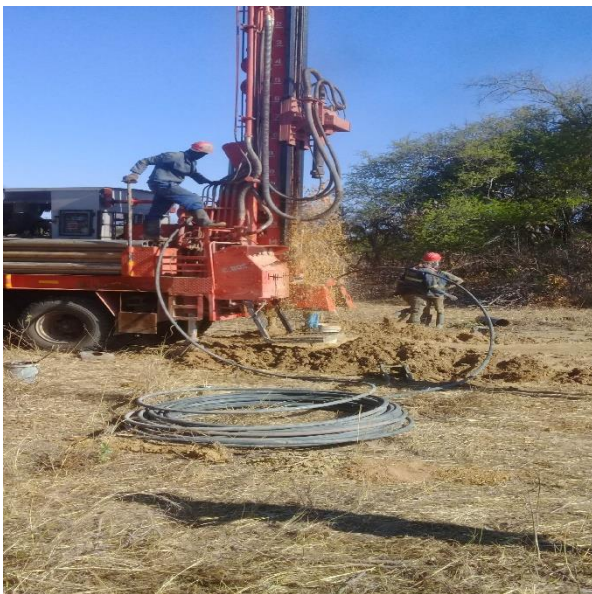
Figure 4 Borehole Drilling

The first 16 meters turned out that it was loose formation, therefore, 8 inch metal casings were put up to 18 meters and this resulted paying an extra amount of ZMW 25,056. Use of metal casings was necessary as the first 16 meters was loose formation and having such casings will enable community members derive maximum benefits for decades.

It is gratifying to note that the drillers struck water at a depth of between 55 and 69 meters, which translates to the fact that the drilled borehole will most likely be an all year round source of safe and clean drinking water. The solar powered water facility has a 140 mm PVC casing to a depth of 90 meters while 16 meters has metal casings and will be equipped with a 1 HP submersible pump. Based on the advice that was given to Caritas Monze by the technician, installation will be done at a depth of 70 meters.

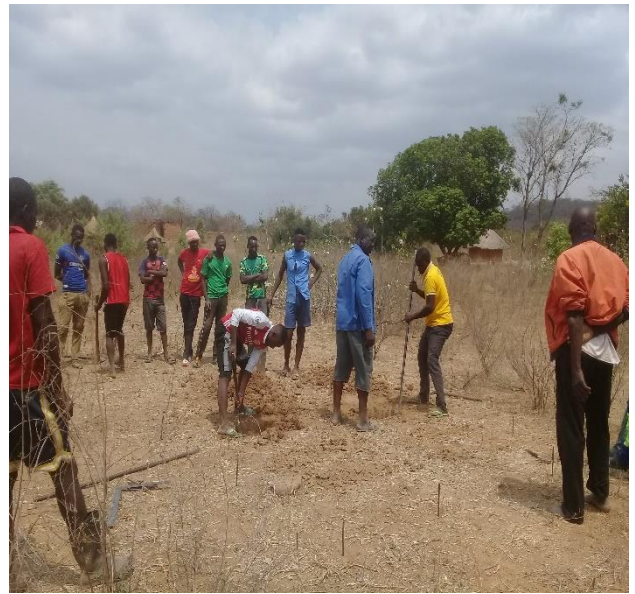
Figure 2 Digging a foundation for the Water Tank Stand

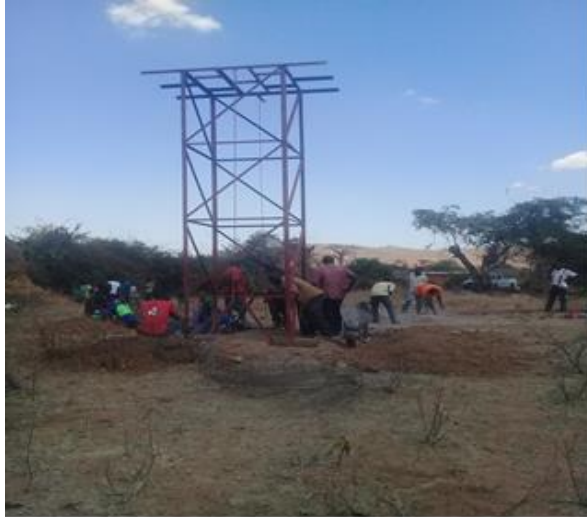
Figure 6 Erecting the water tank stand

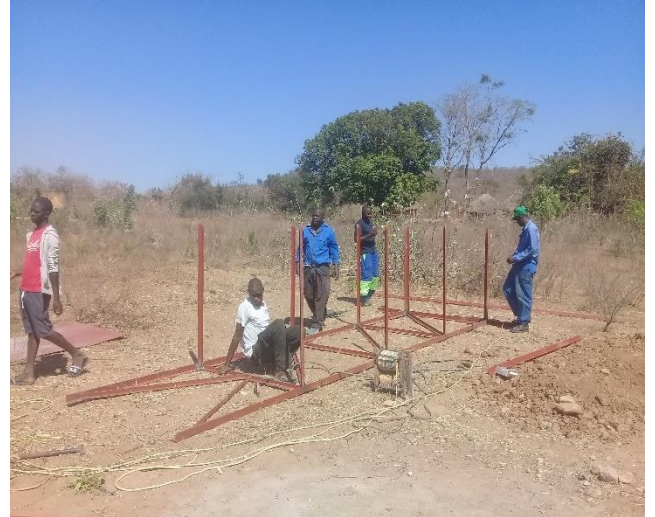
Figure 5 Fabrication of the 5 meter water tank stand

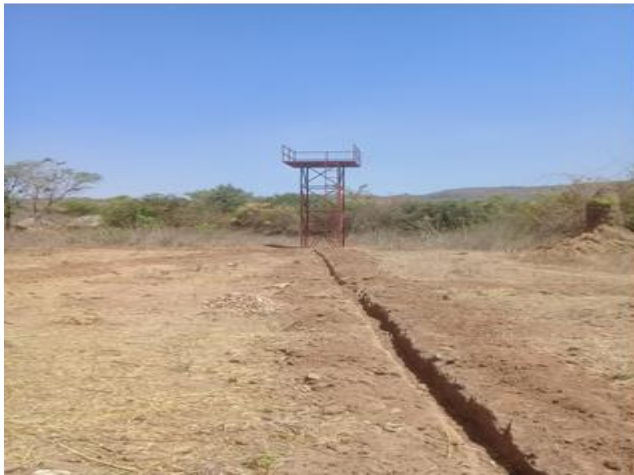
Figure 7 Preparing for laying of pipes

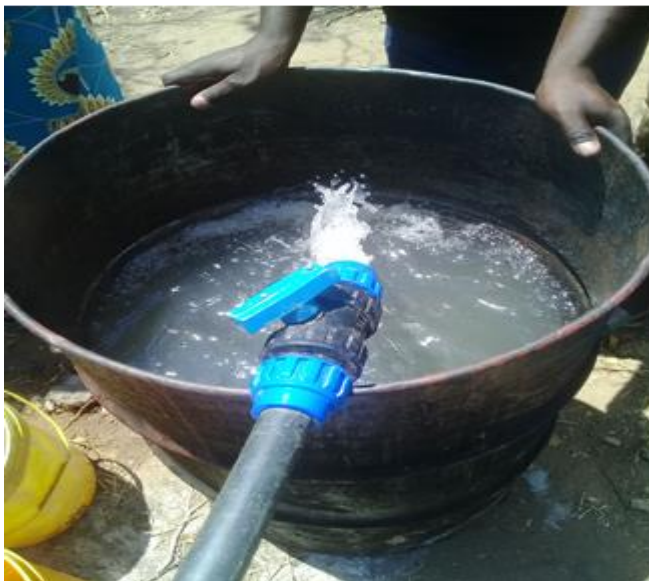
Figure 8 Pumping Test
